**Flood Control Project Maintenance  
Levee Inspections**

**Maintenance Issue Types Only, Levee Inspection Report By Mile - Fall 2016**

**Reclamation District No. 2091 Chase**

Waterway	Bank	Unit Miles	Inspection Start/End	Inspector
Unit No. 01 San Joaquin River	Right	7.46	10/26/2016 10/26/2016	Richard Willoughby

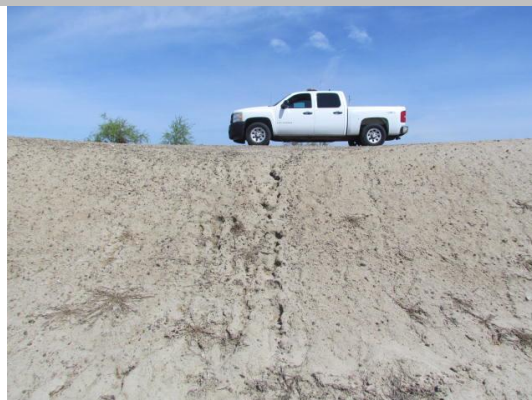
Photo 1 of 4 : FA\_2016\_RD2091\_318\_15\_20161007\_00002.jpg

LM Start	0.23	Rating **	U	Issue No.	15
LM End	0.23	Issue Type +	Ma	Location *	LS
Category	Earthen Levee			GPS Latitude/Longitude	
				Start	End
Item	Erosion / Bank Caving			37.541550 °	37.541550 °
				-121.096742 °	-121.096742 °
DWR ID	DWR_RD2091_01_s_2016_15				
Comment Code					
E1 : Note and monitor erosion site.					
Inspector Comment					
Caving on landward shoulder possible collapsed pipe. Caving is 34 feet long over one inch depth.

Looking west at dip on landward levee shoulder.

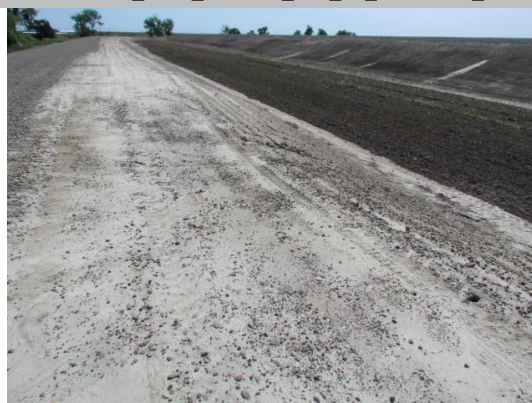
Photo 2 of 4 : FA\_2016\_RD2091\_318\_15\_20161007\_00003.jpg

Looking southeast at depression along landward shoulder.

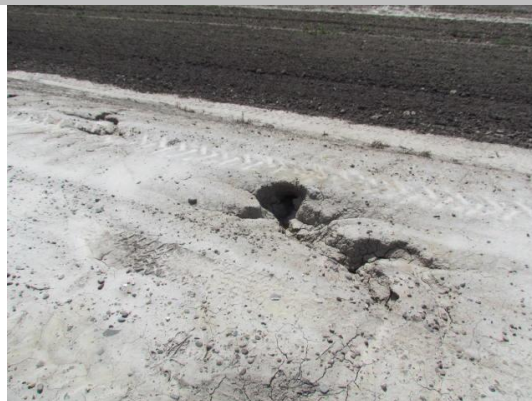
Photo 2 of 5 : FA\_2016\_RD2091\_318\_16\_20161007\_00007.jpg

LM Start	0.25	Rating **	M	Issue No.	16 (cont)	
LM End	0.28	Issue Type +	Ma	Location *	LS	
Category	Earthen Levee			GPS Latitude/Longitude		
				Start		End
Item	Erosion / Bank Caving			37.541492°	37.541408°	
				-121.097052°	-121.097453°	
DWR ID	DWR_RD2091_01_s_2016_16					
Comment Code						
E1 : Note and monitor erosion site.						
Inspector Comment						
Several fringer erosions and possible rodent holes along landward shoulder and slope.

Looking east at fringer erosion and possible rodent hole on landward slope.

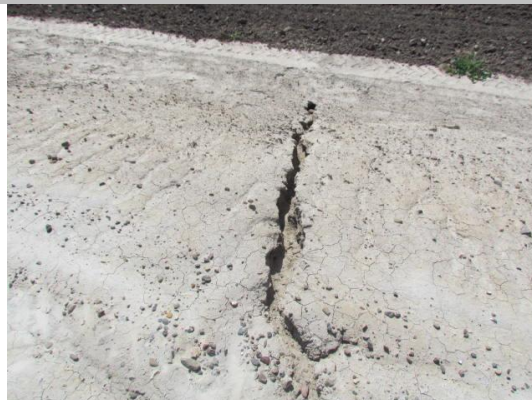
Photo 3 of 5 : FA\_2016\_RD2091\_318\_16\_20161007\_00008.jpg

Looking east at fringer erosion on landward slope.

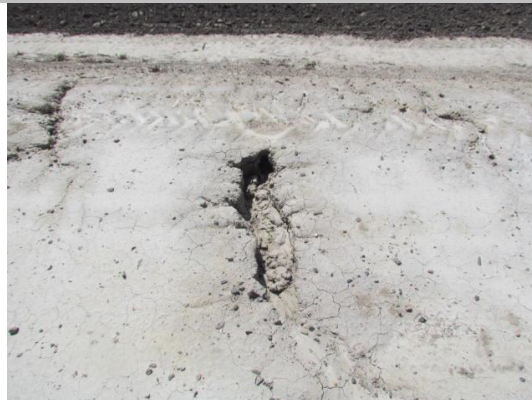
Photo 4 of 5 : FA\_2016\_RD2091\_318\_16\_20161007\_00009.jpg

Looking east at fringer erosion and possible rodent hole on landward slope.

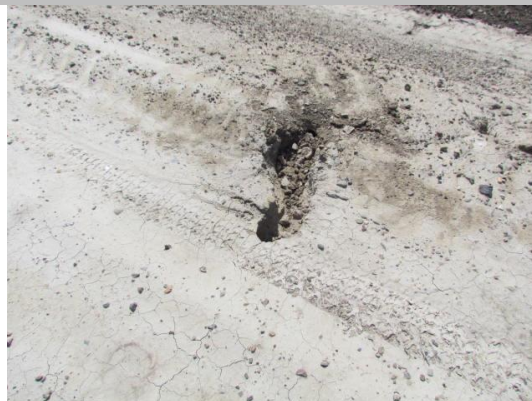
Photo 5 of 5 : FA\_2016\_RD2091\_318\_16\_20161007\_00010.jpg

LM Start	0.25	Rating **	M	Issue No.	16 (cont)	
LM End	0.28	Issue Type +	Ma	Location *	LS	
Category	Earthen Levee			GPS Latitude/Longitude		
				Start		End
Item	Erosion / Bank Caving			37.541492 °	37.541408 °	
				-121.097052 °	-121.097453 °	
DWR ID	DWR_RD2091_01_s_2016_16					
Comment Code						
E1 : Note and monitor erosion site.						
Inspector Comment						
Several fringer erosions and possible rodent holes along landward shoulder and slope.

Looking east at erosion and possible rodent hole on landward shoulder.

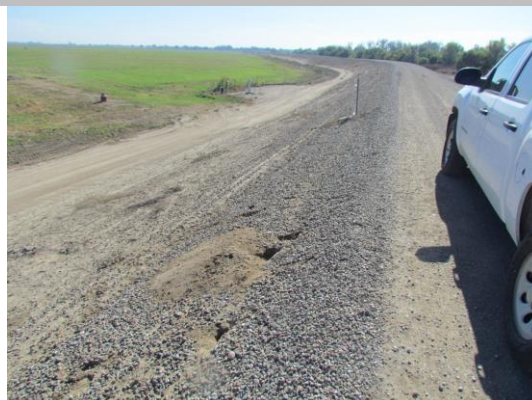
Photo 1 of 3 : FA\_2016\_RD2091\_318\_10\_20161027\_00029.jpg

LM Start	4.85	Rating **	U	Issue No.	10
LM End	4.85	Issue Type +	Ma	Location *	LS
Category	Earthen Levee			GPS Latitude/Longitude	
				Start	End
Item	Animal Control			37.494115 °	37.494115 °
				-121.078100 °	-121.078100 °
DWR ID	DWR_RD2091_01_f_2016_10				
Comment Code					
A3 : No rodents visible, but rodent burrows visible; need to backfill and compact or grout burrows.					
Inspector Comment					
Several large rodent holes on landward slope.

Looking south at several rodent holes on landward slope.

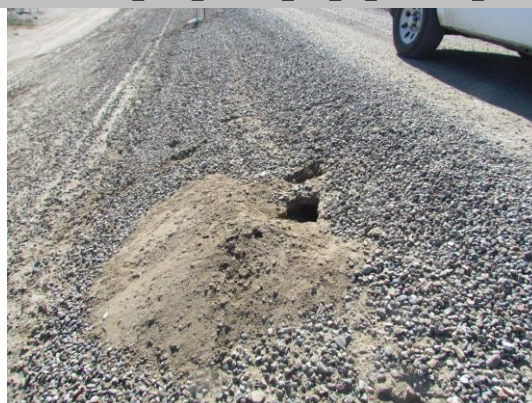
Photo 2 of 3 : FA\_2016\_RD2091\_318\_10\_20161027\_00028.jpg

Looking south at close-up view of rodent holes on landward slope.

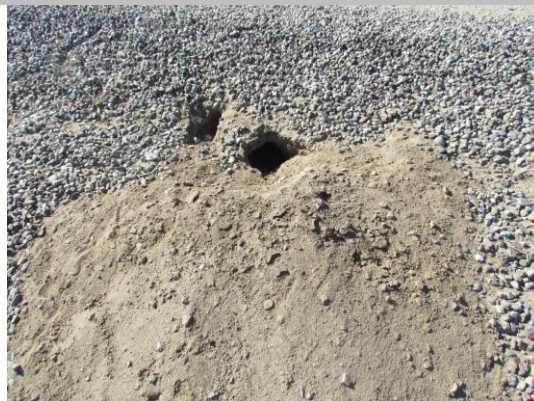
Photo 3 of 3 : FA\_2016\_RD2091\_318\_10\_20161027\_00027.jpg

LM Start	4.85	Rating **	U	Issue No.	10 (cont)	
LM End	4.85	Issue Type +	Ma	Location *	LS	
Category	Earthen Levee			GPS Latitude/Longitude		
				Start		End
Item	Animal Control			37.494115 °		37.494115 °
				-121.078100 °		-121.078100 °
DWR ID	DWR_RD2091_01_f_2016_10					
Comment Code						
A3 : No rodents visible, but rodent burrows visible; need to backfill and compact or grout burrows.						
Inspector Comment						
Several large rodent holes on landward slope.

Looking west at close-up view of rodent holes on landward slope.

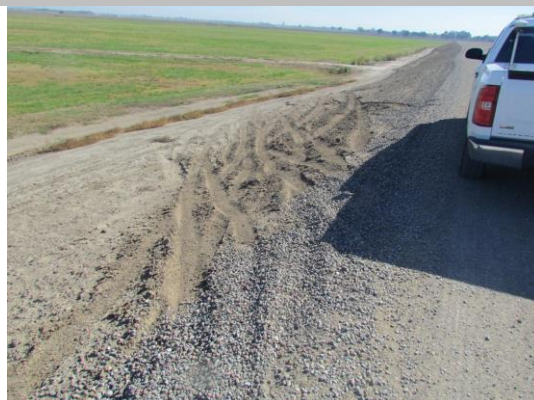
Photo 1 of 2 : FA\_2016\_RD2091\_318\_13\_20161027\_00030.jpg

LM Start	5.20	Rating **	M	Issue No.	13
LM End	5.20	Issue Type +	Ma	Location *	LS
Category	Earthen Levee			GPS Latitude/Longitude	
				Start	End
Item	Slope Stability			37.490756 °	37.490756 °
				-121.073410 °	-121.073410 °
DWR ID	DWR_RD2091_01_f_2016_13				
Comment Code					
S3 : Repair the levee slope damaged by vehicle traffic and prevent access where possible.					
Inspector Comment					
Vehicle traffic damaging slope on waterward and landward slope.

Looking at damage on waterward slope.

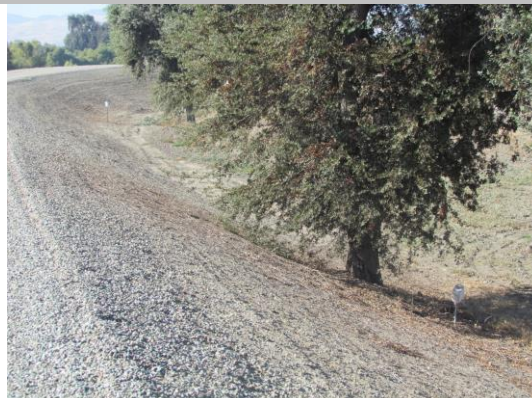
Photo 1 of 2 : FA\_2016\_RD2091\_318\_12\_20161027\_00033.jpg

Looking north at untrimmed tree at landward toe.

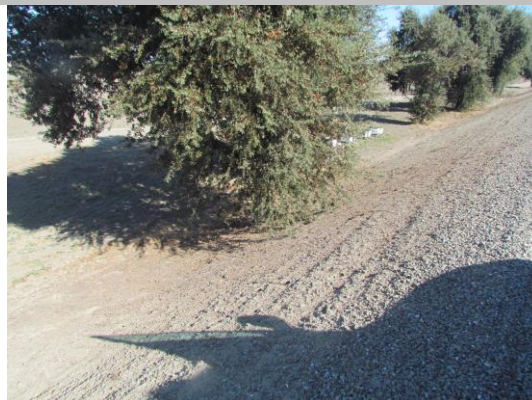
Photo 2 of 2 : FA\_2016\_RD2091\_318\_12\_20161027\_00032.jpg

Look southeast at untrimmed tree at landward toe.

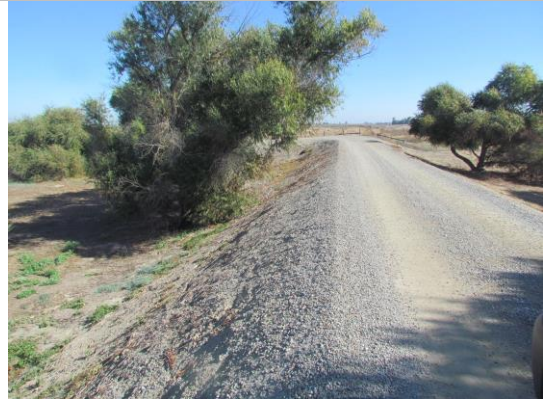
Photo 1 of 1 : FA\_2016\_RD2091\_319\_4\_20161027\_00002.jpg

LM Start	0.30	Rating **	M	Issue No.	4
LM End	0.30	Issue Type +	Ma	Location *	LS
Category	Earthen Levee			GPS Latitude/Longitude	
				Start	End
Item	Trim / Thin Trees			37.541327°	37.541327°
				-121.097895°	-121.097895°
DWR ID	DWR_RD2091_02_f _ 2016_4				
Comment Code					
T1 : Trim trees to at least five feet above ground level.					
Inspector Comment

Looking south at untrimmed tree at landward slope.
